# FINAL REPORT

## THE ACCIDENT INVESTIGATION

OF US BANGLA AIRLINES, BOMBARDIER (UBG-211), DHC-8-402, S2-AGU, AT  
TRIBHUVAN INTERNATIONAL AIRPORT, KATHMANDU, NEPAL

ON 12 MARCH 2018

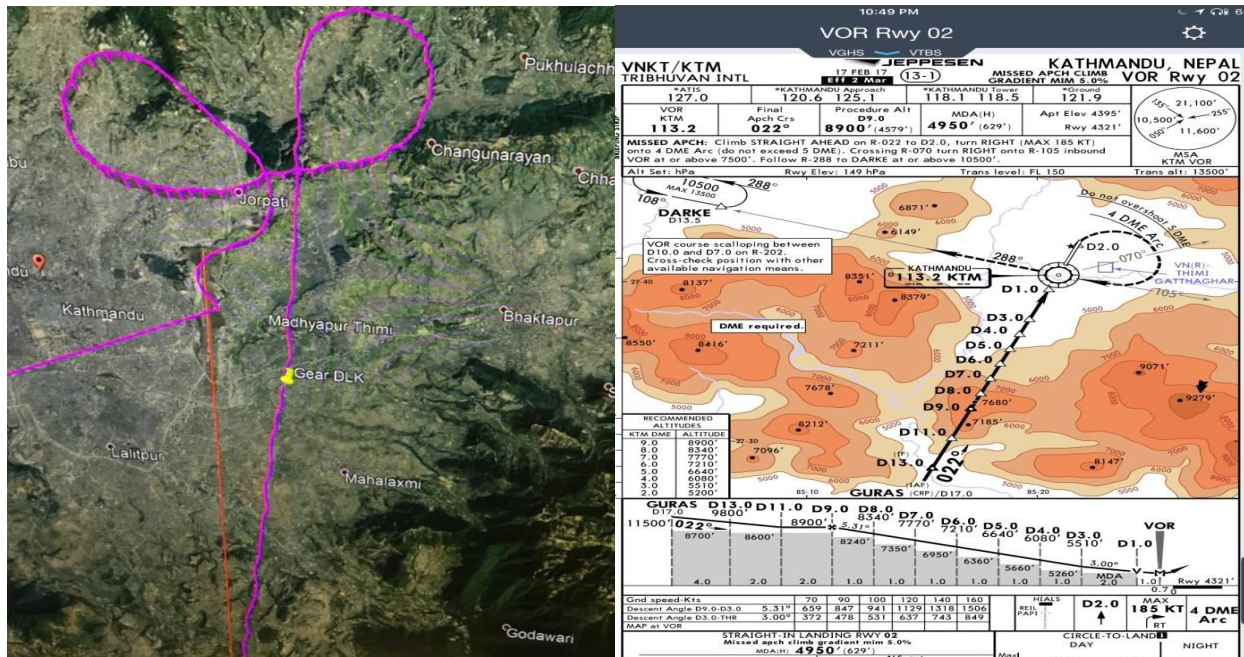
While continuing with the turn through Southeastern direction, the PIC reported that he had the runway in sight and requested tower for clearance to land. The Tower Controller cleared the aircraft to land but when the aircraft was still turning for the RWY it approached very close to the threshold for RWY 20 on a westerly heading and not aligned with the runway. At 08:33:27 UTC, spotting the aircraft maneuvering at very close proximity of the ground and not aligned with the RWY. Alarmed by the situation, the Tower Controller hurriedly cancelled the landing clearance of the aircraft by saying, "Takeoff clearance cancelled".

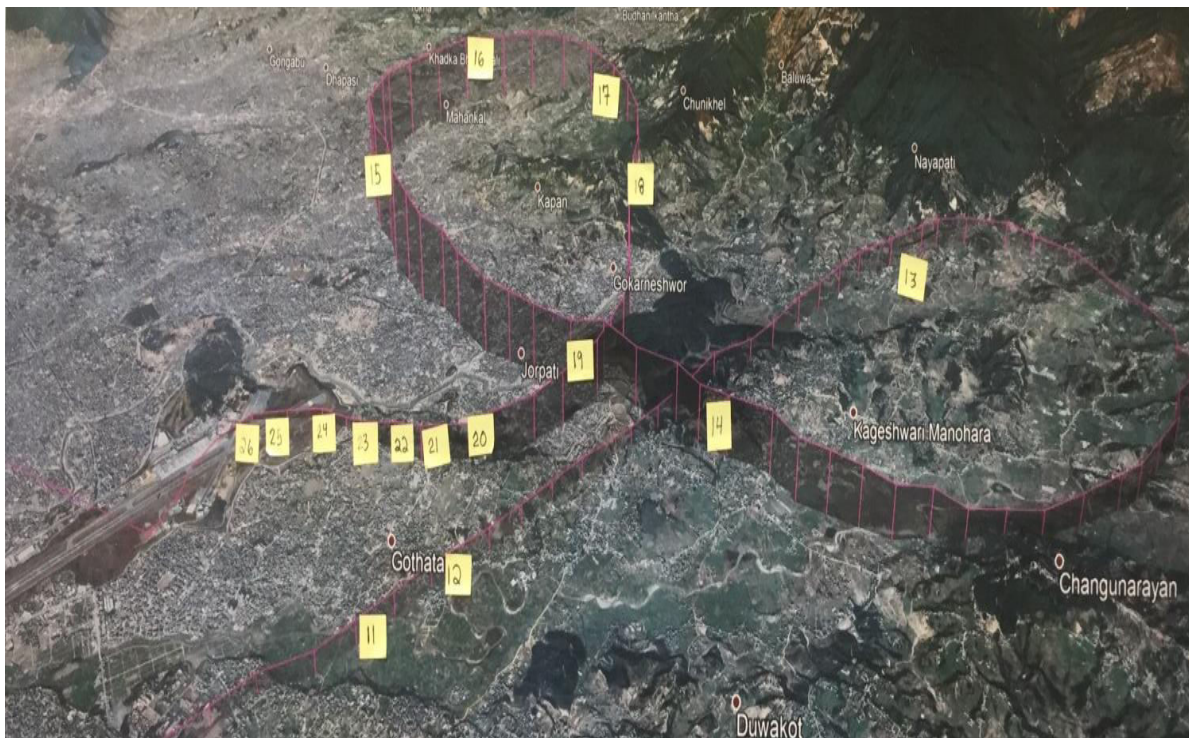
At around 0834 UTC the aircraft touched down at coordinates N27°41'48", E085°21'34", 1700 meters down the threshold with a bank angle of about 15 degrees and an angle of about 25 degrees with the RW axis (approximately heading Southeast) and on the left of the center line of RWY 20, then veered southeast out of the runway through the inner perimeter fence along the rough down slope and finally stopped at coordinates N27°41'41", E085°21'32" about 442 meters southeast from the first touchdown point on the runway. All four crew members (2 cockpit crew and 2 cabin crew) and 45 out of the 67 passengers onboard the aircraft were killed in the accident. Two more passengers succumbed to injury later in hospital during course of treatment. The aircraft caught fire after 6 seconds of touchdown which engulfed major portions of the aircraft.

(Aircraft Movement as depicted by the Animation based on DFDR Data)

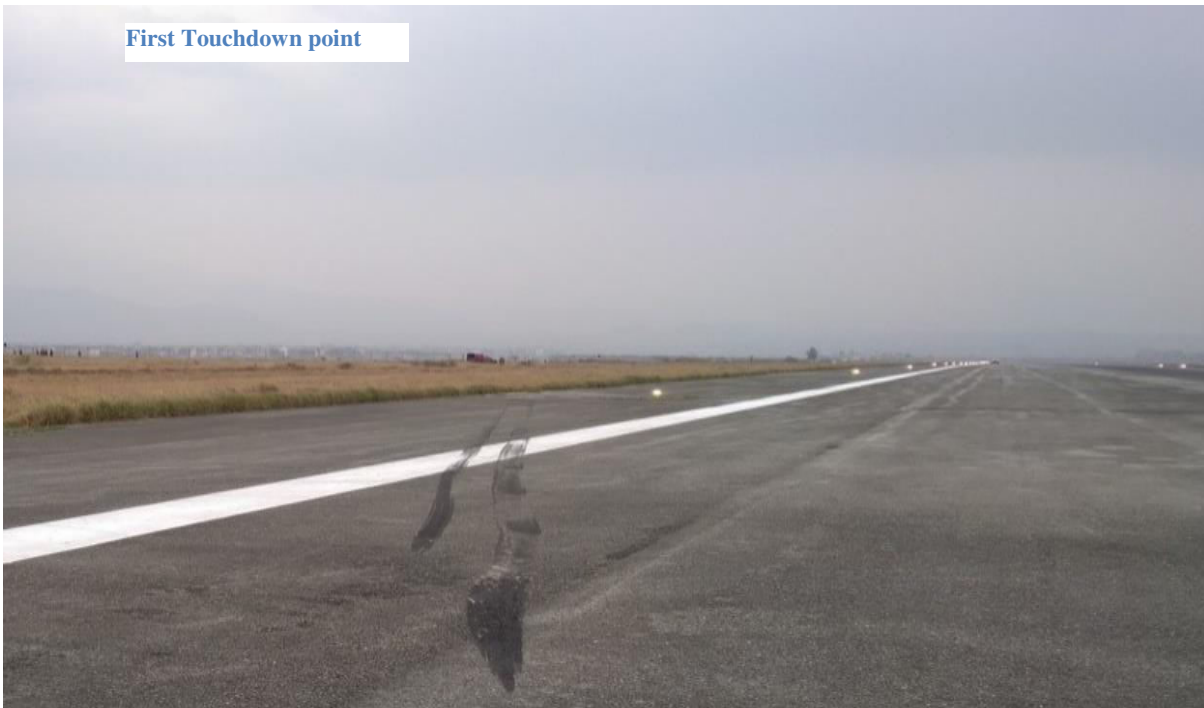
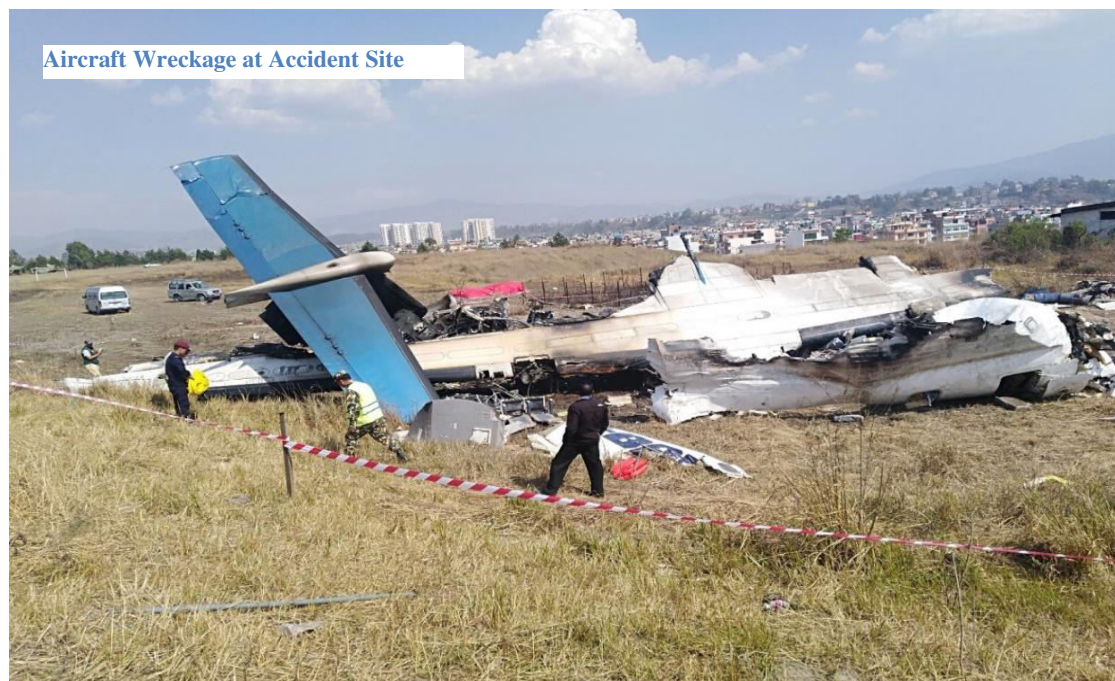
The aircraft touched down at coordinates N27<sup>0</sup>41'48", E085<sup>0</sup>21'34", 1700 meters down the threshold and on the left of the center line of Runway 20, then veered southeast out of the runway through the inner perimeter fence along the rough down slope and finally stopped at coordinates N27<sup>0</sup>41'41", E085<sup>0</sup>21'32" about 442 meters southeast of the runway.

The aircraft was fragmented into number of debris along the rough down slope before coming to a stop. Engines, APU, landing gears were almost detached from the aircraft; wings were broken and most of the aircraft parts were damaged due to post crash fire.
